Non-Chromate Aluminum Pretreatments
Phase II Interim Report
Project #PP0025

September 2004

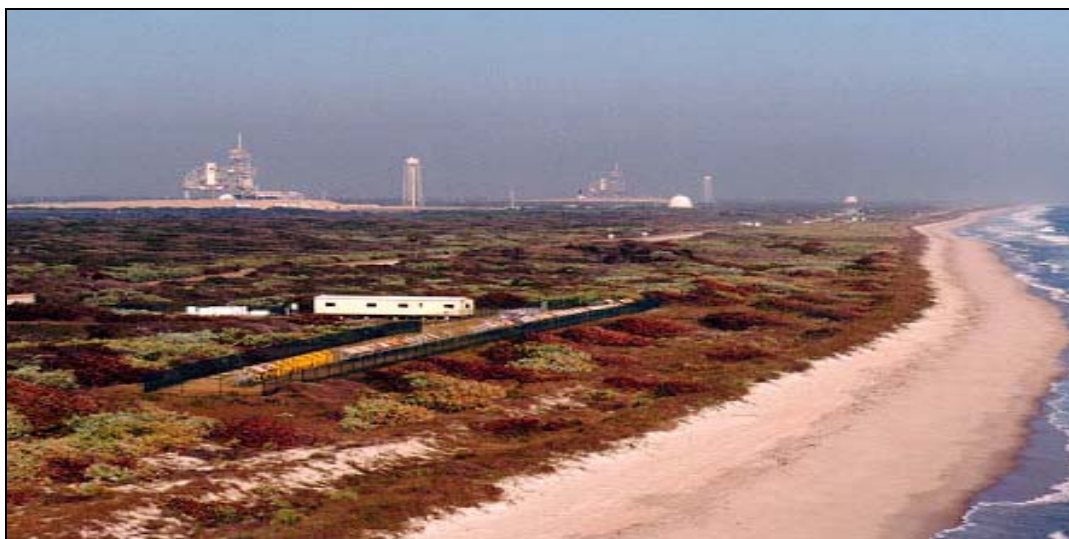
Figure 3.1: KSC Corrosion Testbed Beach-side Aerial View

NASA's test facility is located 1.5 miles south of Launch Complex 39A. Figure 3.1 shows an aerial view of the site.

Test stands are located 30 meters (100 feet) from the mean high-tide line and face the water. Test coupons are installed on yellow, painted steel test stands using porcelain insulator stand-offs. The rack angle of the coupons is 30 degrees from horizontal.

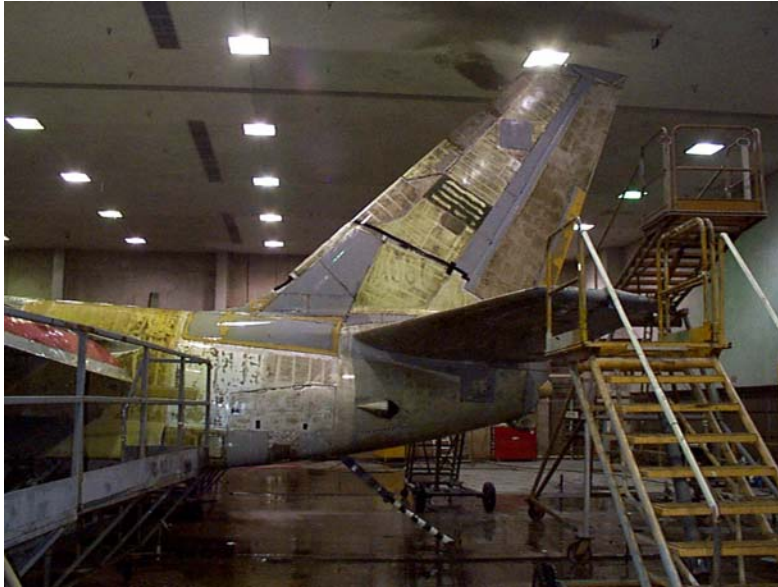
Figure 4.2: Fuselage Station 496-transition area

TCP was spray applied over the horizontal and vertical tail surfaces, and aft fuselage. North Island's normal spray procedures were followed, whereby, the conversion coating materials were sprayed on wetted surfaces beginning at the bottom and working upward. The aircraft was rinsed with tap water at 50-70 psi following each process chemical application. A bluish iridescence was evidenced in the TCP application areas, but there was little color change relative to the chromated areas.

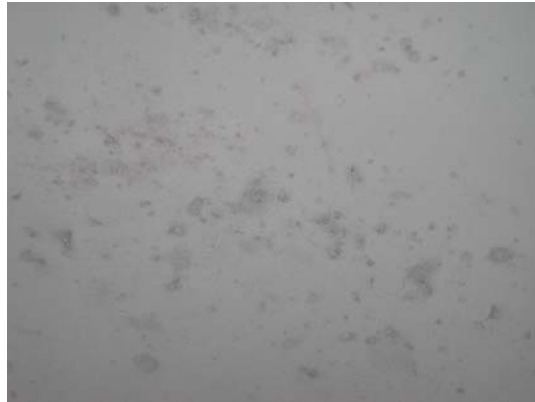
Figure 4.5. Open Area Corrosion

by the maintenance personnel that this aircraft exhibited more corrosion than was normally observed. The aircraft showed signs of corrosion along some of the fastener rows, and in some surface areas away from fasteners or joints. The average thickness of the paint adjacent to an observed filiform corrosion area was 2 mils. This hits mid-range of the recommended thickness (1.7-2.3 mils) for SPT. Corrosion not necessarily adjacent to fasteners could be found in areas around the outer mold-line of the aircraft.

A specific cause for the extra corrosion was not identified but two potential causes were identified: insufficient corrosion protection by the TCP/SPT coating system or inadequate rinsing during processing. Excessive TCP residue left during processing may cause corrosion in non-chromate coating systems. Since neither can be proven independently or acting together no conclusion can be reached other than more testing with this coating system is required before use in the field.

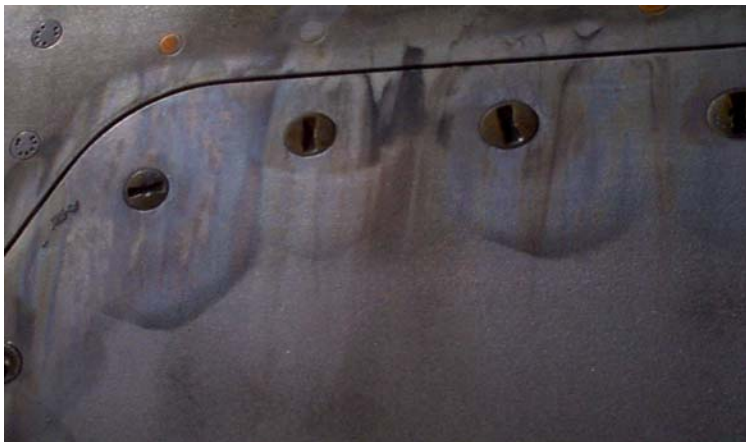
Figure 4.8: Iridescent Blue Coloration of As-deposited TCP

While the surface was still wet, black streaking was evident in some areas that were glass bead blasted the day before. Presumably aluminum clad or anodize was removed leaving a bare aluminum substrate (likely AA7075). These bare areas took on more color than areas not treated with glass bead blasting. The dark streaks persisted after the TCP was rinsed off and the surface had dried (Drying conditions: 75.3 degrees @ 25% RH).

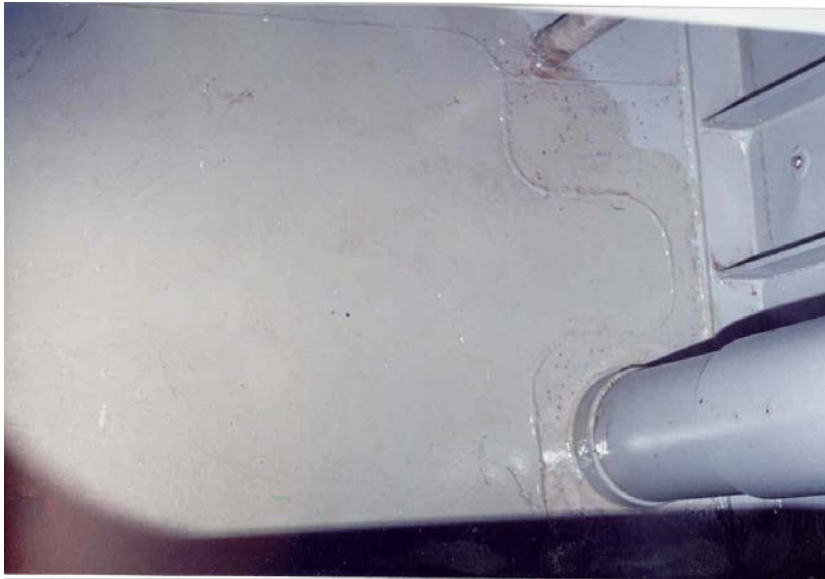
Figure 5.1: LCAC-26 Oily Waste Tank with TCP Test Patch

The first test area was the deck of the oily waste tank, which can contain MIL-H-23699 hydraulic fluid, seawater, and engine cleaning detergents. This is an area where adhesion loss is observed due to breakdown of the organic coating.

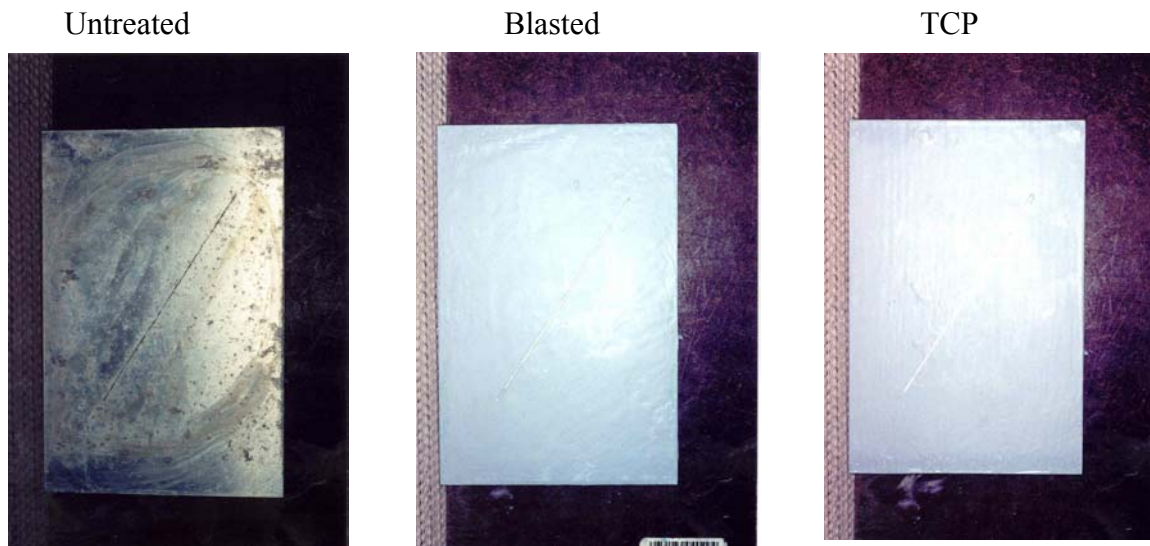
Figure 5.3: AA5456-H116 Coupons (Bare, Blasted, or TCP) coated with MIL-DTL-24441B F150/151 – 1.5+ years Beach-side Exposure

Beach-side testing coupons were exposed on 30 degree racks at the Little Creek, VA site for 4 years. Within 6 months of exposure, the scribed painted coupons with no surface preparation exhibited undercutting from the scribe. The garnet-blasted coupons developed undercutting around 3.5 years, the TCP coupons are still in testing, no undercutting is evident.

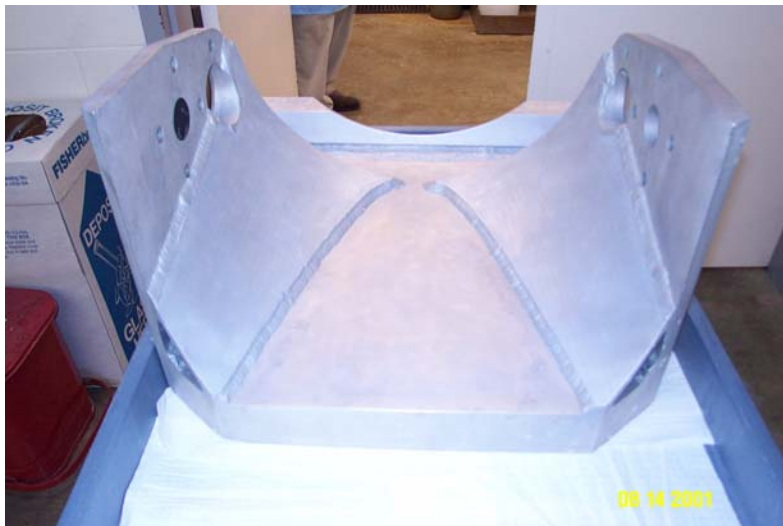
Figure 5.7: TCP Coating after Drying

8. Rinsed thoroughly with cold tap water followed by DI water.
9. Allowed components to air-dry for one hour. Figure 5.7 shows a component with a dried TCP film.

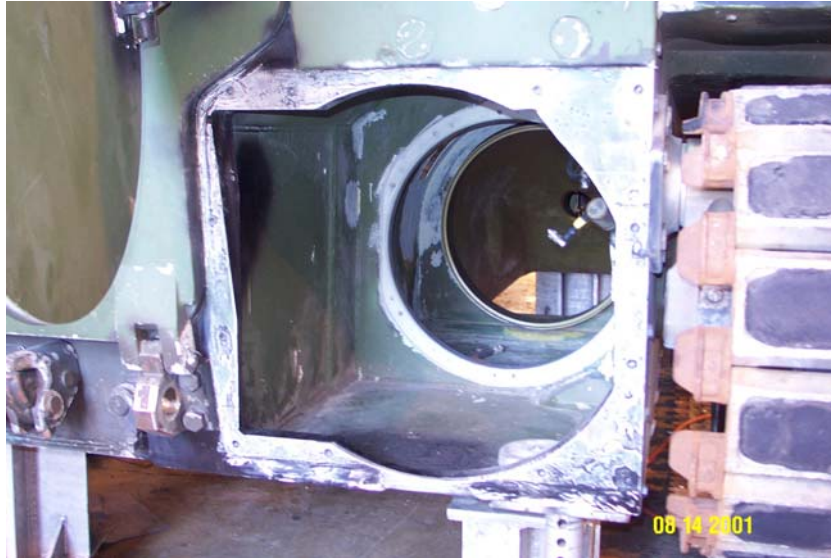
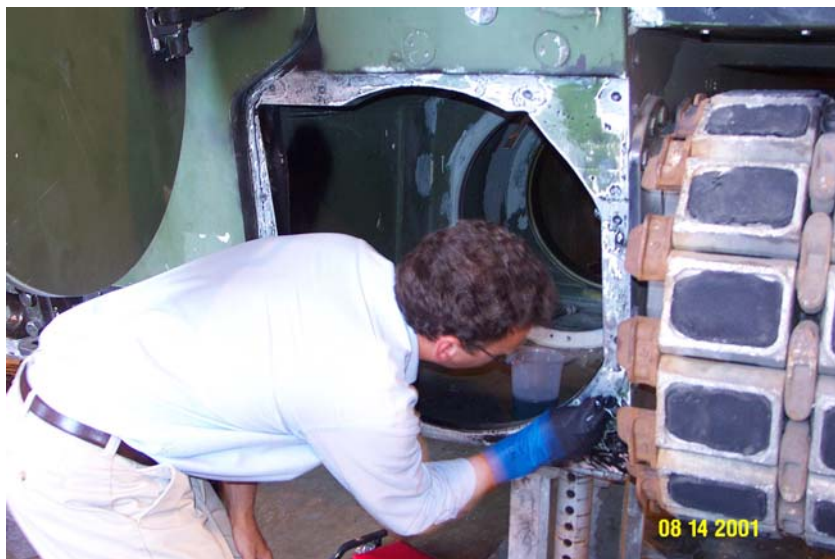
While the components were being painted on the afternoon of August 14, members of the Inorganic Coatings Team (ICT) applied a TCP coating to the mating surfaces of the seal plates on the port and starboard sides where corrosion and adhesion damage had occurred. In addition, the P1 team requested that TCP coating be applied to the port and starboard water jet thrust plates. These areas were cleaned and mechanically prepped by the P1 team. Immediately after being wiped clean with an alcohol wipe, the surfaces were treated with TCP. The TCP was wiped onto the surfaces using a clean cotton rag and allowed to dwell for 10 minutes. Repeat applications of TCP were made after approximately three to seven minutes. No TCP solution ran onto adjoining surfaces. After the dwell, un-reacted solution was wiped from the treated surfaces using a second clean rag saturated with clean DI water. The surfaces were then allowed to air-dry with help from a large fan. That evening, the P1 crew primed these surfaces using MIL-PRF-85582 NC material applied from Sem-penTM touch-up paint applicators. Figures 5.11 and 5.12 depict the TCP touch-up process.

Figure 5.10: Seal Plate Mating Surface after Corrosion Removal

Figure 5.11: Application of TCP Coating on Seal Plate Mating Surface

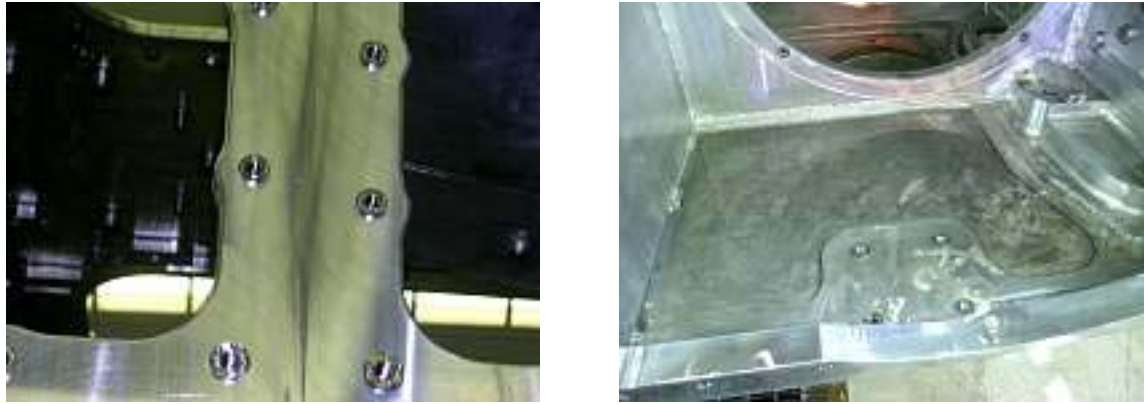
Figure 5.16: Minimal TCP Color Change Observed Near Inserts

After TCP-color application, a visible color change was not observed. A darker brown/gray coloring was visible in areas where TCP streaked/ran off from inserts. See Figure 5.16. This same coloring could also be seen where TCP pooled in pocketed areas of the vehicle. An overall very slight smoky appearance could be seen on the vehicle. The iridescent appearance from the non-color change TCP was more evident than the observed color change from the TCP-C application. The dark colored streaking and well areas were examined the following morning and a powdery coating was not present in those areas. Regardless of film coloration, no adhesion failures were seen with this vehicle.

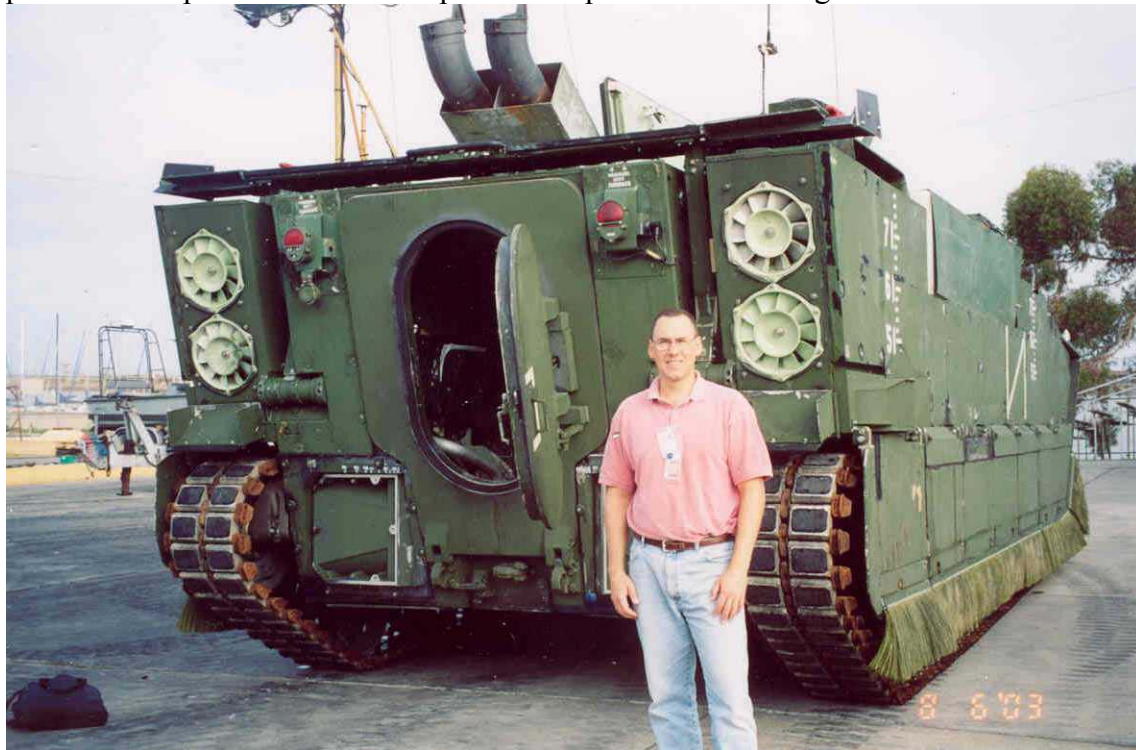
Figure 5.18: P1 Inspection – C. Matzdorf at AVTB, Camp Pendleton – August 2003

It was noted that the steering buckets and brackets around them on both sides were different than previously and had large unpainted areas that were beginning to surface corrode and pit. It was recommended that these surfaces be cleaned of corrosion, treated with TCP, primed and top-coated as soon as possible to prevent further degradation.

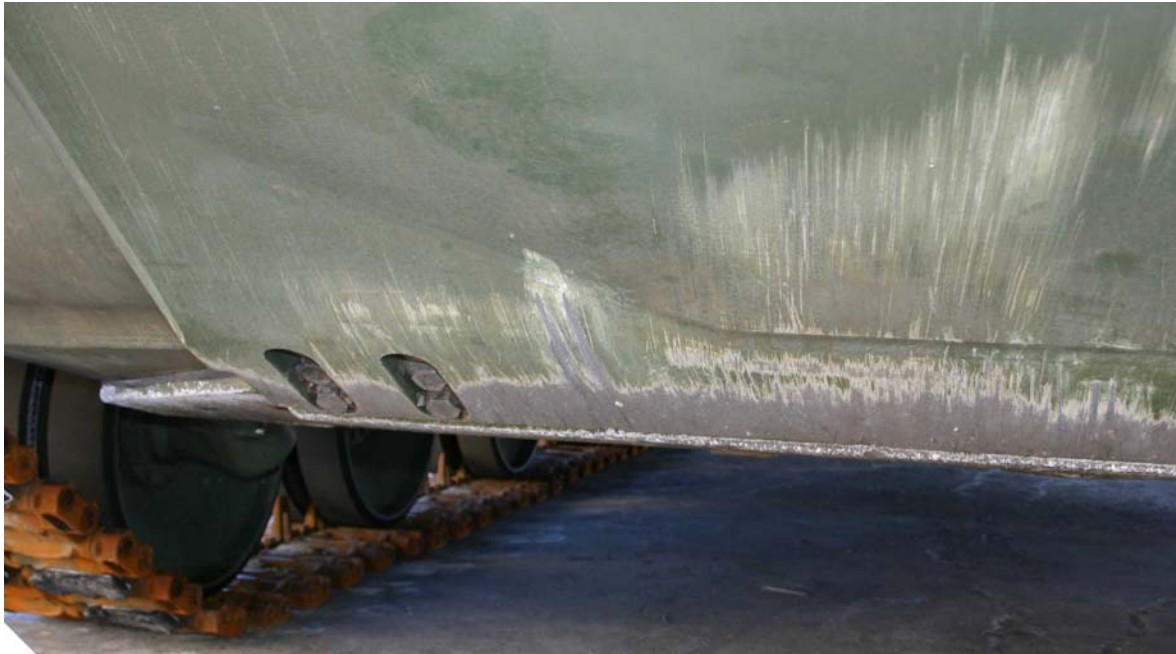
Figure 5.20: E7 Lower Anterior Hull

It was observed that both vehicles had areas of paint loss due to scraping and gouging caused by rocks and debris around track areas, and on the lower anterior-hull from abrasion during water-to-land movements. Figure 5.19 shows severe scraping damage on the lower anterior-hull of E7 – no additional undercutting from the damaged areas is evident.

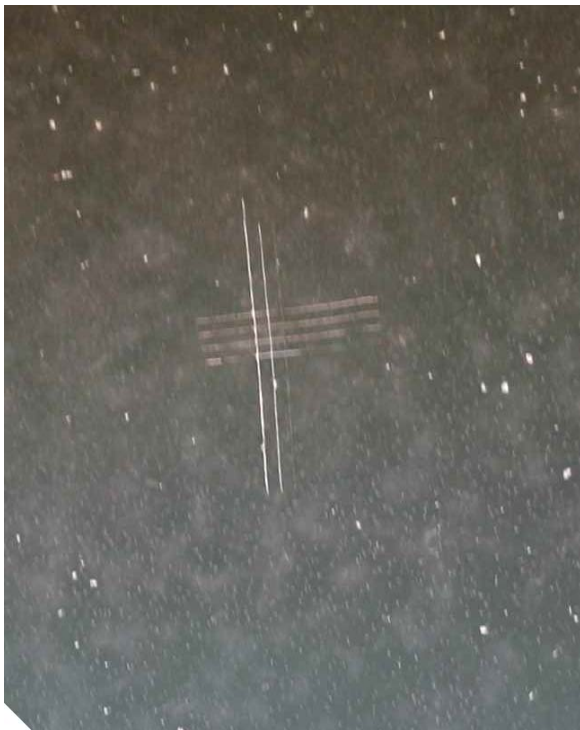
Figure 5.21: E7 Cross-hatch Scribe

Figure 5.21 shows a cross-hatch scribe area on E7 from the initial QC paint adhesion inspection at LATP – no undercutting or peeling of the paint system from the scribe was observed. No corrosion product was evident in the scribed area.

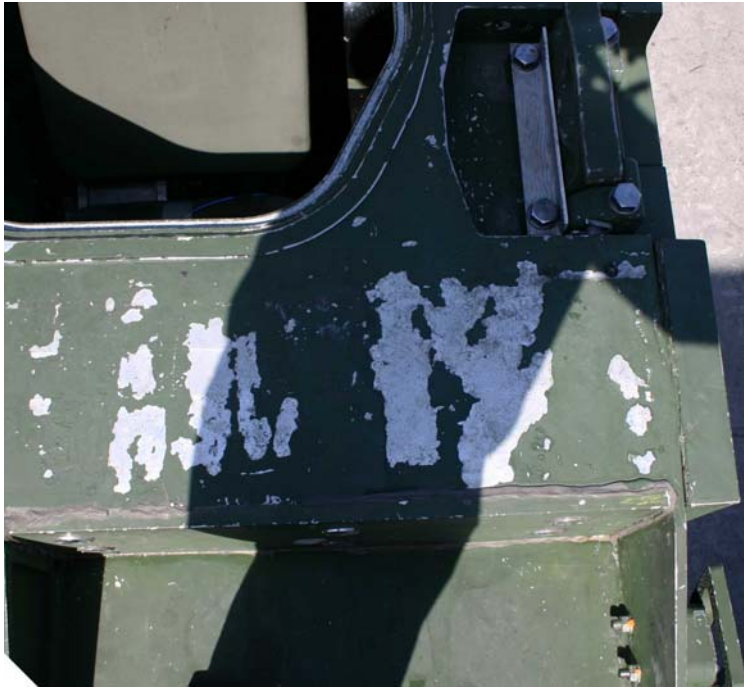
Figure 5.22: E2 Driver's Hatch

E2 exhibited significantly more corrosion, additional undercutting, paint adhesion problems from damaged areas than did E7. Figure 5.22 shows paint chipping on E2's top, port side, in front of the driver's hatch. This area sees a high volume of traffic, but similar damage was not evident on the E7.

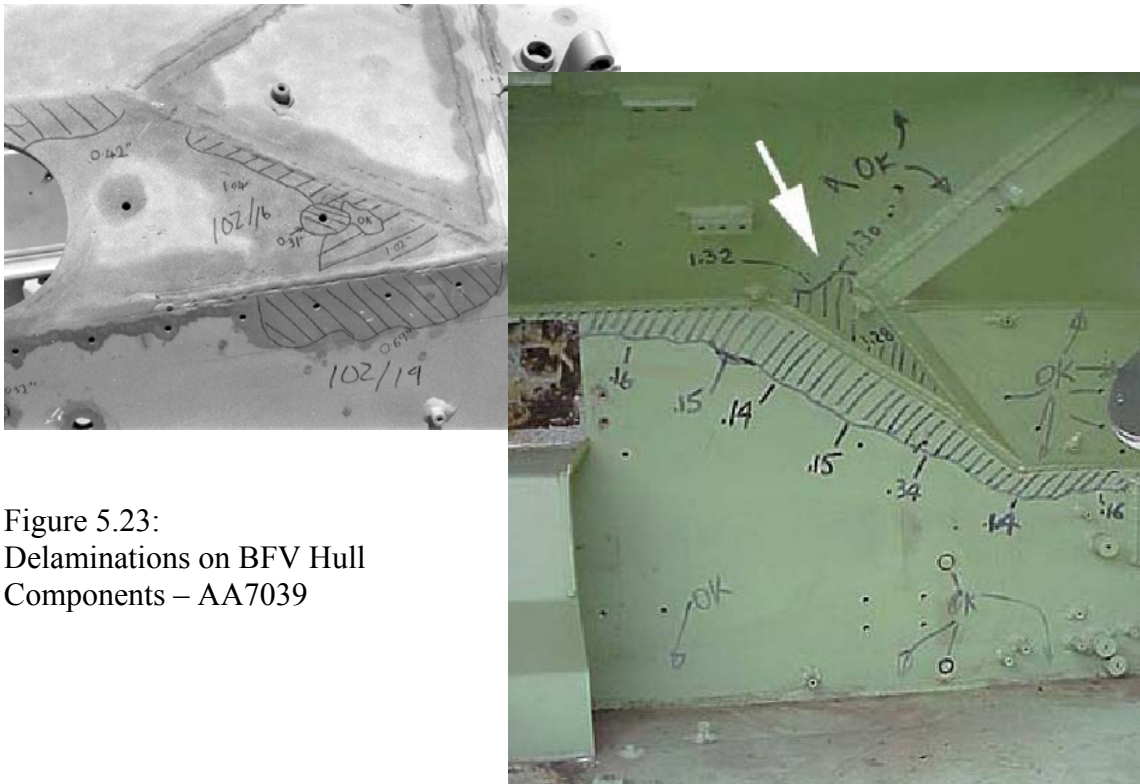
Figure 5.23:
Delaminations on BFV Hull
Components – AA7039

UDLP-York, the OEM, is still upgrading and retrofitting BFV's to the new M2A3, M3A3 variations. In depot maintenance and rework efforts, it was noticed that the aluminum armor alloy, AA7039, evidenced severe intrametallic delamination probably caused by environmentally assisted stress corrosion cracking (SCC). The decision was made to move to a manual surface prep method, as it was thought that the immersion process trapped moisture in small cracks and tight areas on the vehicles, thereby accelerating the delamination. The PM CS Environmental Management Team (EMT) has suggested an SCC evaluation of AA7039 with the current process versus an immersion process using both chromate control and TCP to ascertain the differences, if any, between the chemical immersion or manual surface preparation methods.

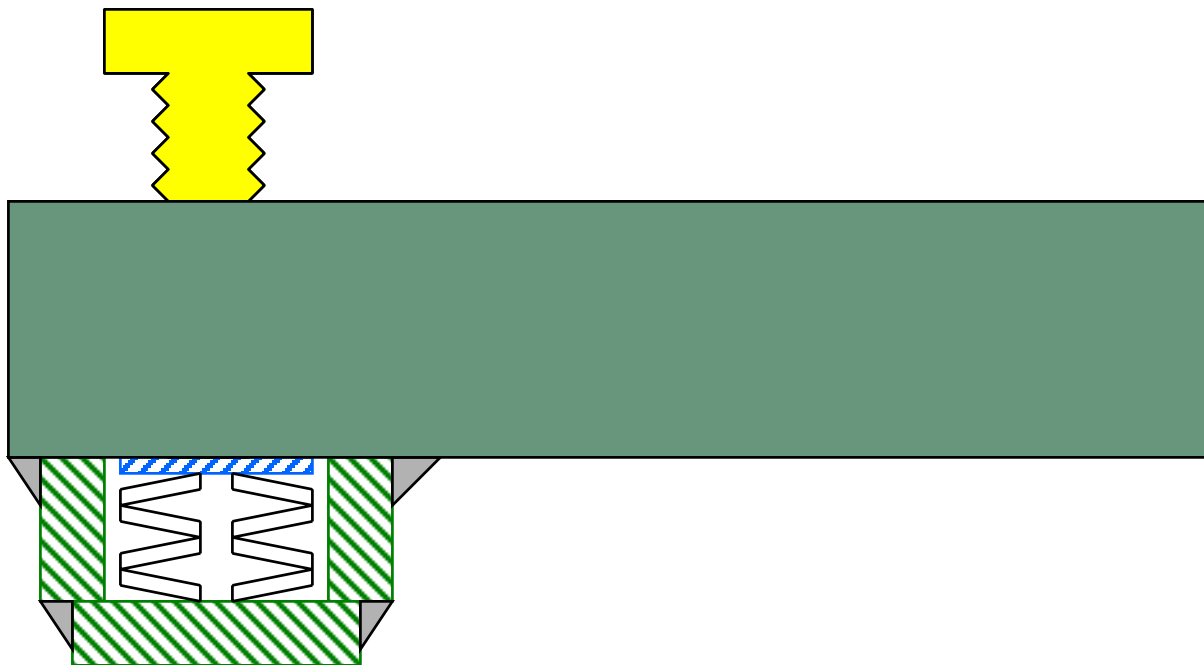
Figure 5.39: SCC test specimen schematic

The sample size will be 8 inches wide, 12 inches long, and 1 inch thick. The selected proportional fastener torque will create 5-ksi tensile stress.
